Re: Notice of Violation
RCRA Compliance Evaluation Inspection – National Recycling, Inc.
EPA I.D.: MND 051 727 592

RCRA COMPLIANCE EVALUATION INSPECTION REPORT

SITE NAME: National Recycling, Inc.

DATE OF INSPECTION: November 14, 2012

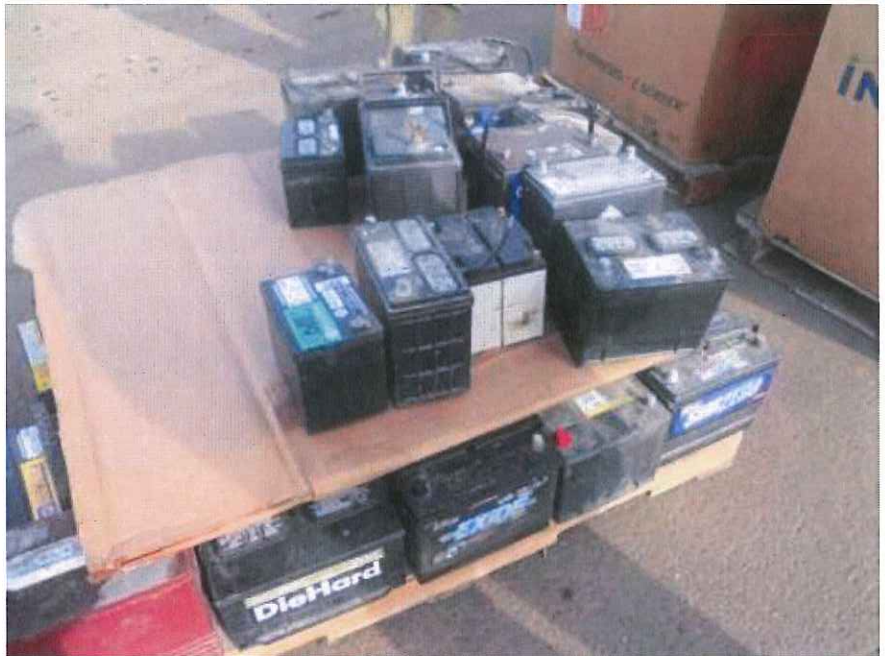
Disk Number 1
Photo Number 1
Photo Filename DSCN0495.JPG
Date/Time 11/14/2012
11:59:00 AM
Photographer Jamie Paulin

Battery Storage Area (Outside storage location). The batteries eventually were shrink wrapped and stored on a pallet prior to shipment.

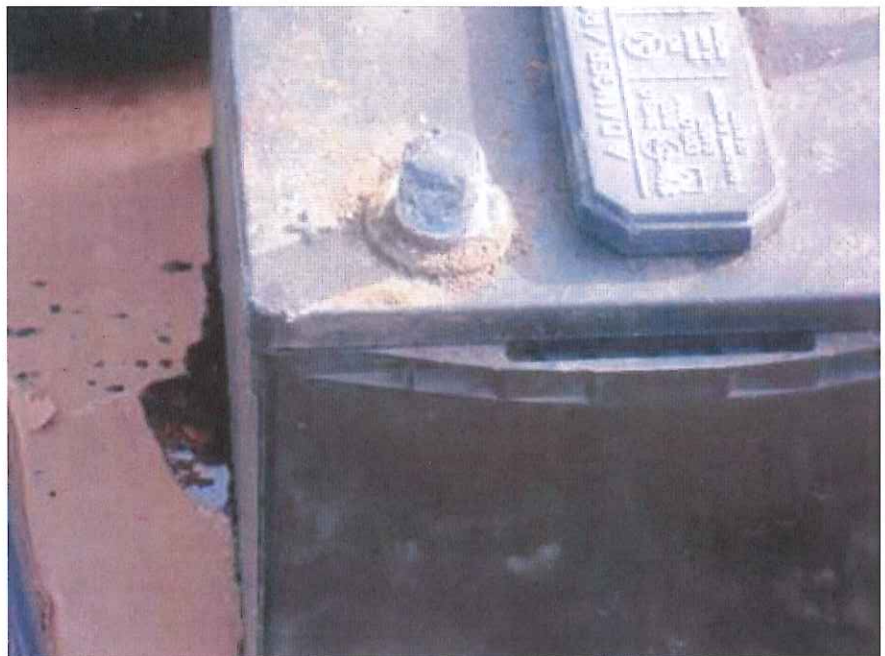
Disk Number 1
Photo Number 2
Photo Filename DSCN0496.JPG
Date/Time 11/14/2012
12:00:00 PM
Photographer Jamie Paulin

At the time of the inspection, NRI was storing a battery that showed evidence of leakage, which was not being stored in a container that was: 1) closed; 2) structurally sound; 3) compatible with the contents of the battery; and, 4) lacking evidence of leakage, spillage, or damage that could cause leakage under reasonably foreseeable conditions. Therefore, NRI failed to properly store universal waste batteries in violation of the above-mentioned generator requirement.

Mr. Mark explained that eventually the batteries are shrink-wrapped and stored on a pallet prior to shipment off-site. However, brown liquid was located under one of the batteries in this area. The brown liquid appeared to be battery leakage. *See*, photographs 1 and 2.

Brown liquid located under a battery in the Battery Storage Area. Possible battery leakage.

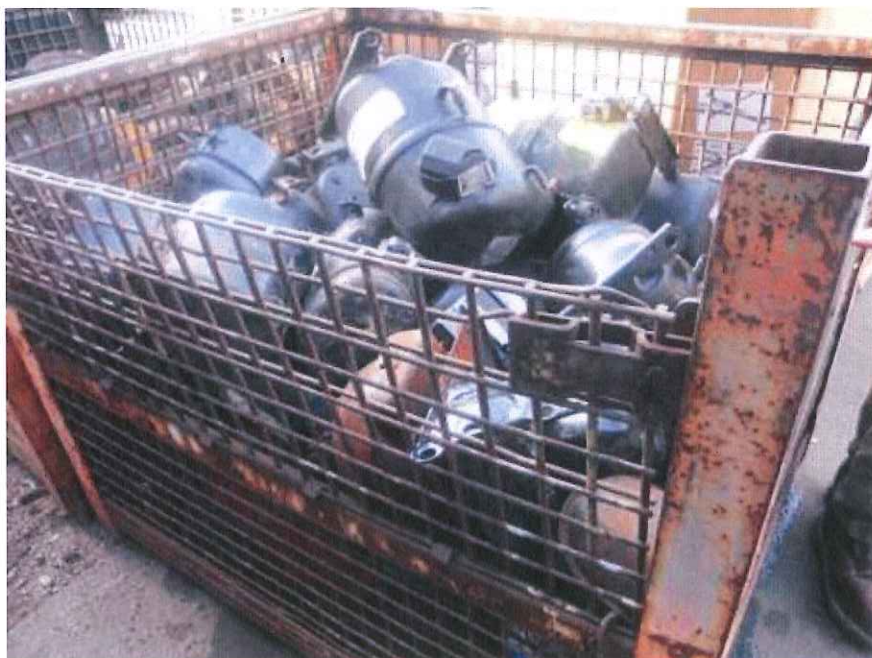
Disk Number 1
Photo Number 4
Photo Filename DSCN0498.JPG
Date/Time 11/14/2012
12:04:00 PM
Photographer Jamie Paulin

We then proceeded to another bin storage area, located outside of the facility, on the west side of the property. NRI was storing PCB light ballasts in a cardboard box. They were also storing sealed containers that had been removed from various types of process equipment in a steel crate. Oil appeared to be leaking at the bottom of the crate from the containers and onto the concrete pad. *See*, photographs 3, 4 and 5.

Sealed containers from various equipment were being stored in an open bin, located in outside storage area. Oil appeared to be leaking at the bottom of the crate out of the containers onto the concrete pad.

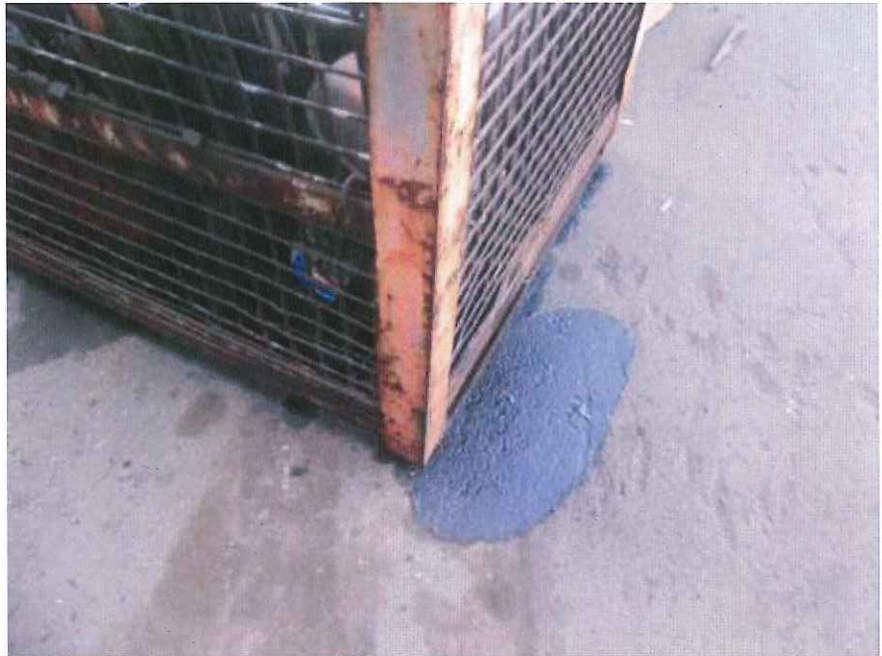
Disk Number 1
Photo Number 5
Photo Filename DSCN0499.JPG
Date/Time 11/14/2012
12:04:00 PM
Photographer Jamie Paulin

At the time of the inspection, NRI was storing an unidentified liquid on the pavement, located near a crate that was storing sealed containers that had been removed from

various types of process equipment. NRI failed to determine if this waste was hazardous in violation of the above-mentioned generator requirement.

A liquid had collected underneath the crate that was storing sealed containers. It appeared to be oil leaking from the crate.

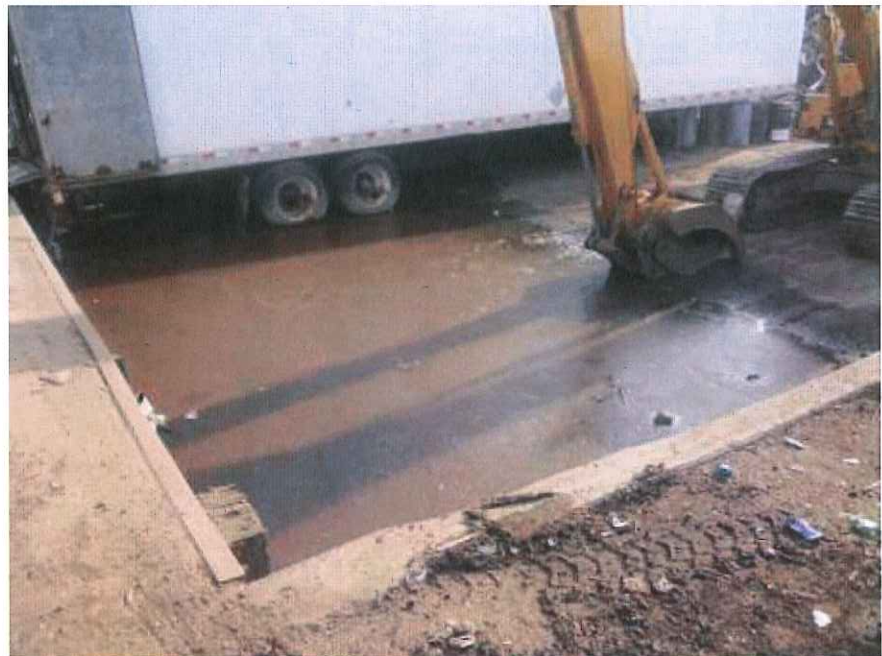
Disk Number 1
Photo Number 6
Photo Filename DSCN0500.JPG
Date/Time 11/14/2012
12:14:00 PM
Photographer Jamie Paulin

From the bin storage area, I inspected the shipping dock, located outside on the east side of the property. A box truck was parked in the dock. The truck's back end was positioned toward the dock, the truck doors were open and a ramp was set inside the door for loading and unloading. Icy, muddy rainwater had collected within the dock. *See*, photograph 6.

Shipping dock. Icy, muddy rainwater had collected in the dock.

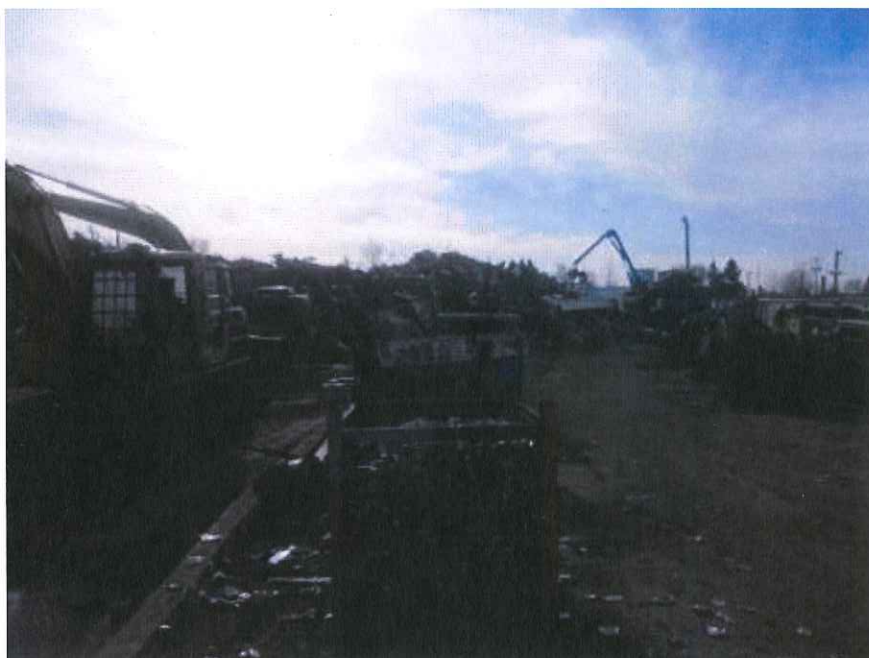
Disk Number 1
Photo Number 7
Photo Filename DSCN0501.JPG
Date/Time 11/14/2012
12:14:00 PM
Photographer Jamie Paulin

Overview of scrap metal storage located outside on the property facing South.

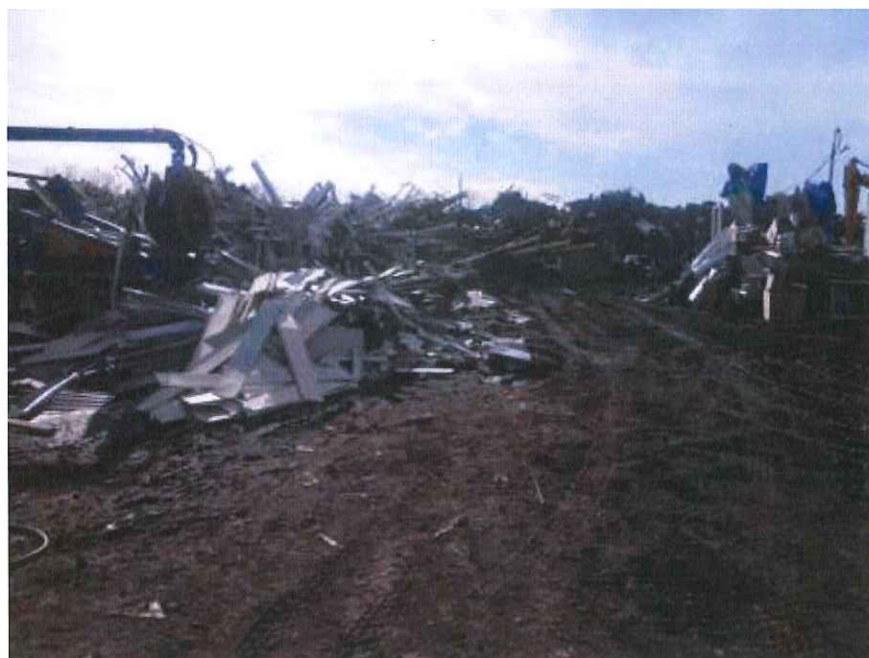
Disk Number 1
Photo Number 8
Photo Filename DSCN0502.JPG
Date/Time 11/14/2012
12:18:00 PM
Photographer Jamie Paulin

Overview of scrap metal storage located outside on the property facing South.

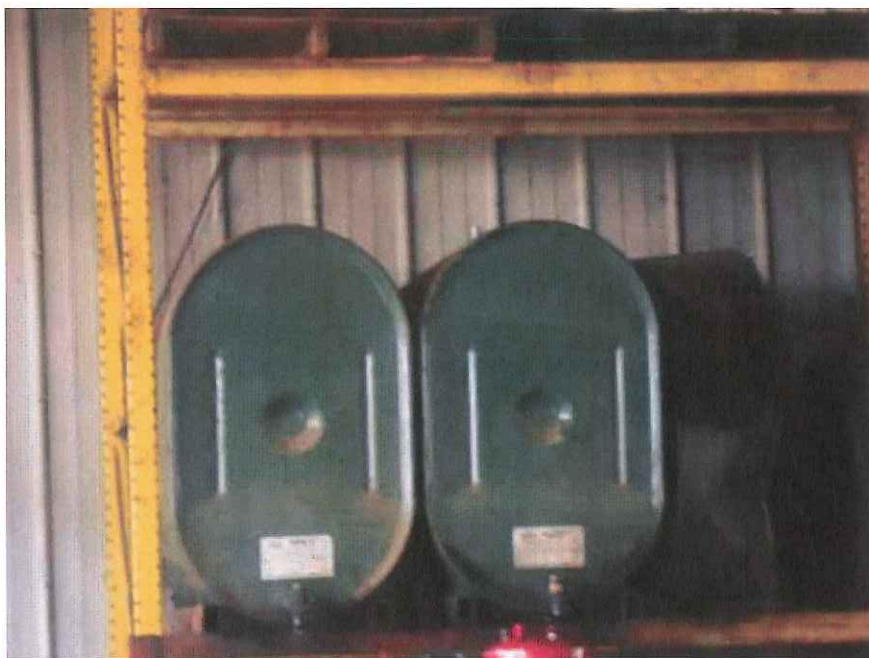
Disk Number 1
Photo Number 9
Photo Filename DSCN0503.JPG
Date/Time 11/14/2012
12:22:00 PM
Photographer Jamie Paulin

Lastly, I inspected the inside of the facility on the west side of the building. Two un-used fuel containers were being stored on a shelf in this area. The containers did not contain labels identifying their contents.

Two fuel containers were being stored inside of the facility on a shelf.
